Bureau of Mines Report of Investigations/1985

Fire Tests of Five-Gallon Containers Used for Storage in Underground Coal Mines

By F. J. Perzak, T. A. Kubala, and C. P. Lazzara

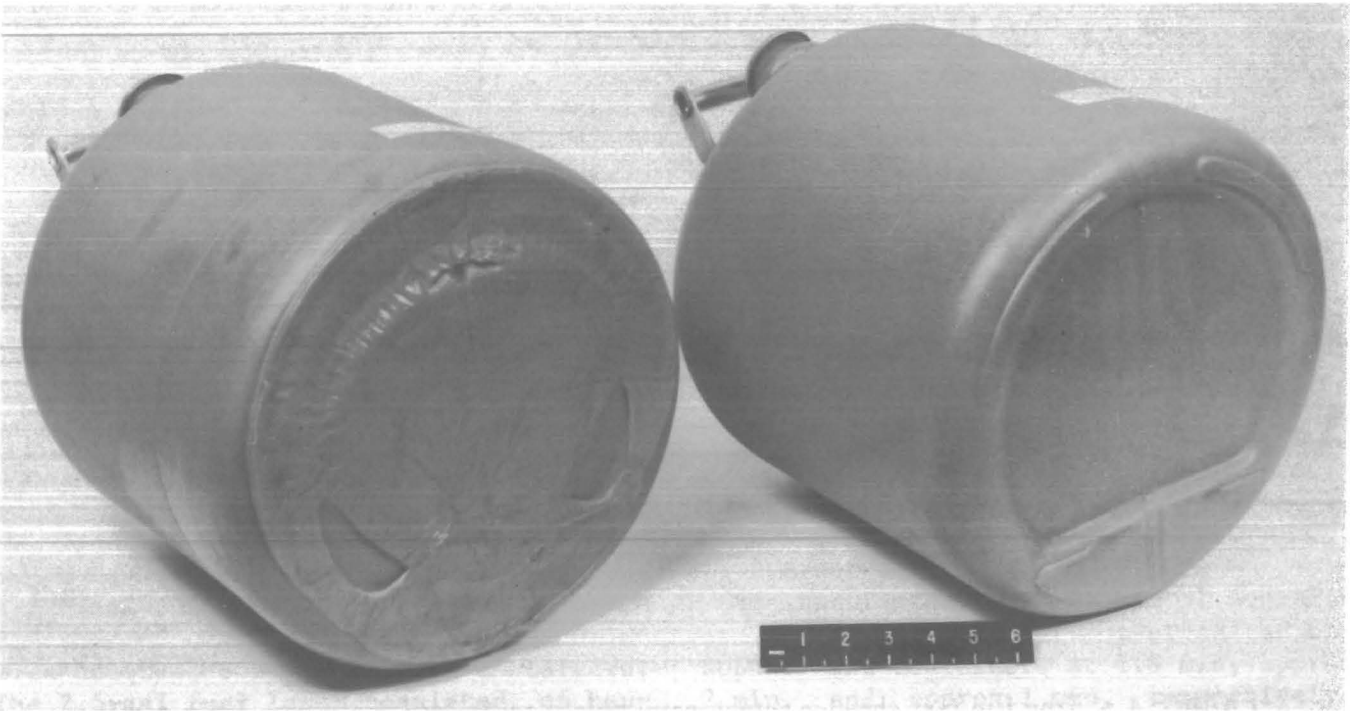
FIGURE 3. - Plastic safety container after 1/2-h contact with hot plate at 572° F (left) and a new container (right).

The hot-plate melting tests showed that plastic safety containers could withstand 572° F for about 1/2 h without leaking hydraulic oil. Figure 3 shows the melted bottom of a plastic container and a new container. The high-density polyethylene was stable to temperatures up to 250° F, so temperatures from 300° F to 572° F were used. At 300° F and 450° F, the containers leaked after contact times of 5 h and 2 h, respectively. These long endurance times were a result of the ribbed construction of the container bottoms and the cooling effect of the 2 gal of hydraulic oil contents, which never exceeded 170° F.

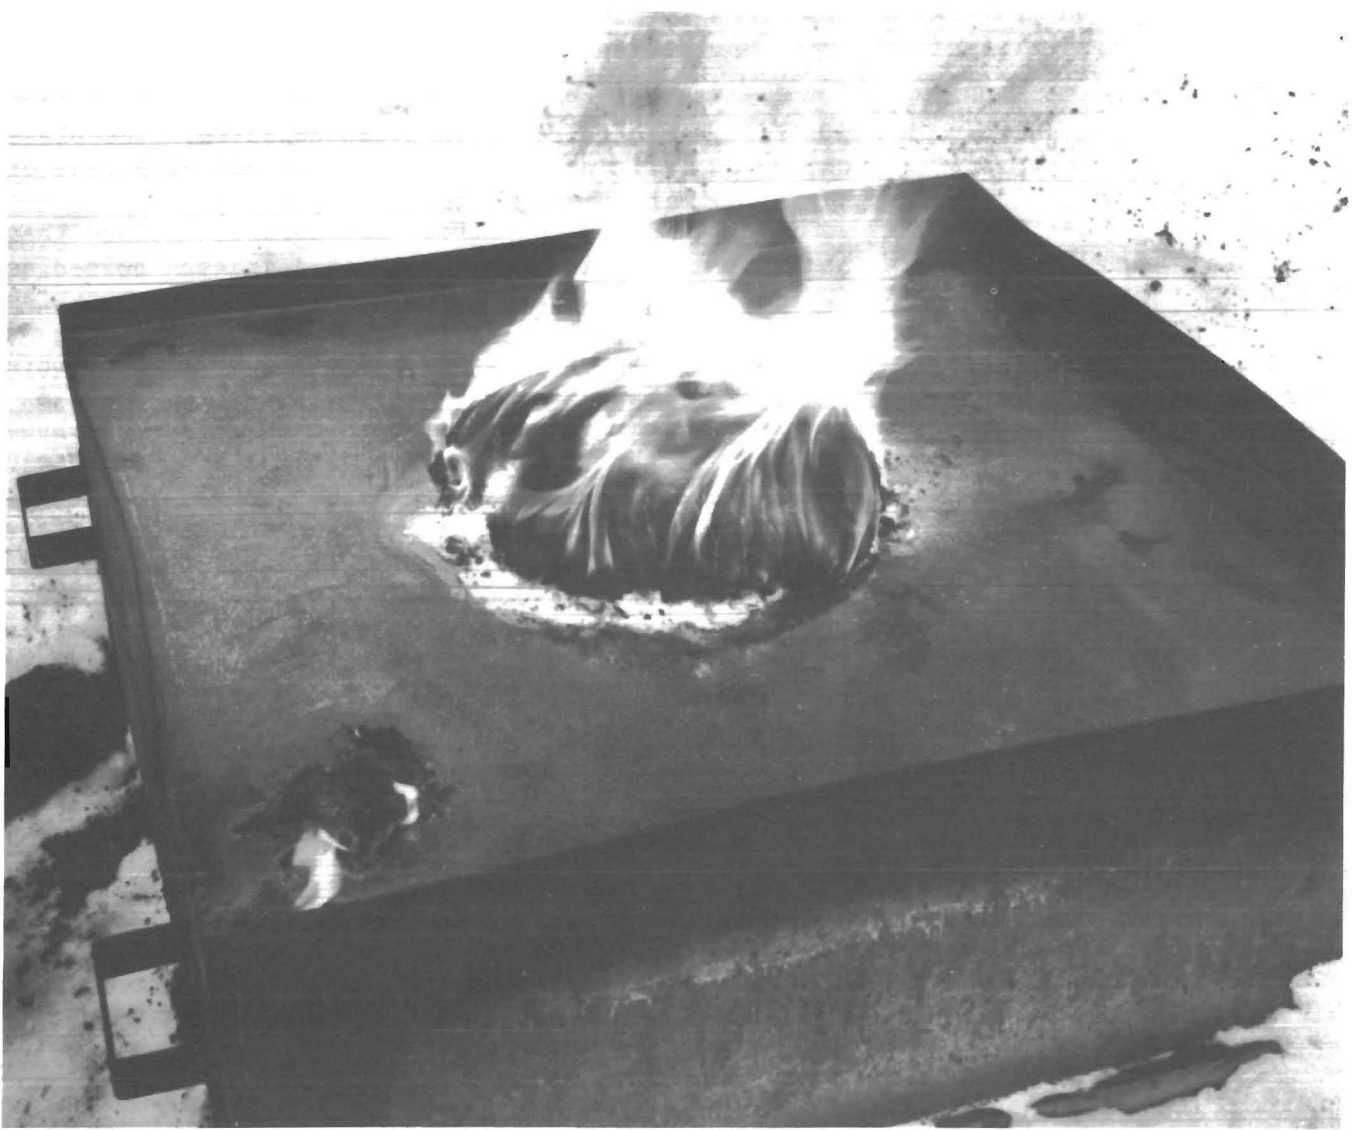
FIGURE 5. - Remnants of plastic pail and 35 lb of grease 8 min after tray fire has self-extinguished.

Plastic tubes and pails containing high-temperature greases do not present any more of a hazard than cardboard containers, which are now permitted. The greases burn as a coherent mass and do not spread widely in a fire. (Figure 5 shows 35 lb of grease burning after the plastic pail that contained it was destroyed.)

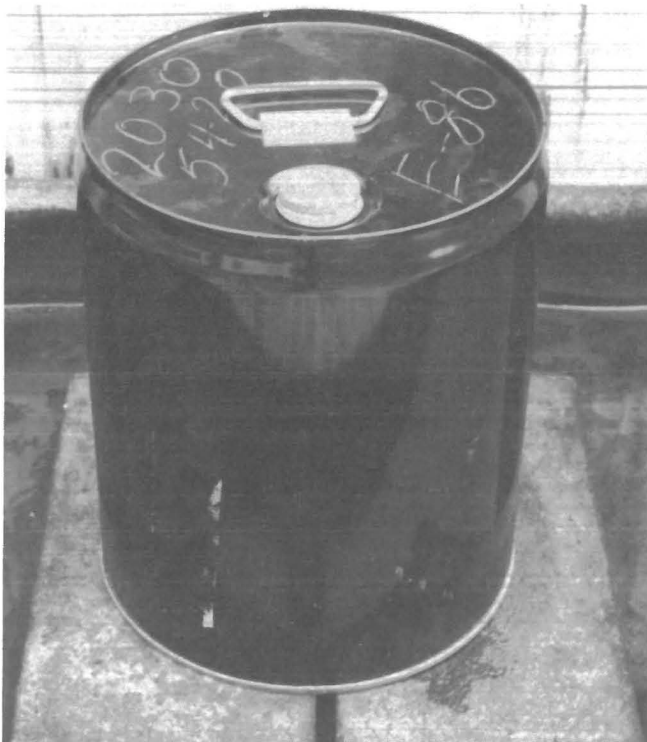
FIGURE 8. - Black metal container prior to standard tray fire test.

tray fire arrangement. Figure 8 shows a black container in the tray before the fire. The standard container contents was 1 gal of NFR hydraulic oil; however, for special tests, kerosene was also used. The standard fuel loading, fire, and container contents were designed to simplify the test so that others could easily evaluate the performance of other containers. Tray fire tests should be performed at an ambient temperature of $60 \pm 20^\circ$ F to obtain a 4-min burning time.

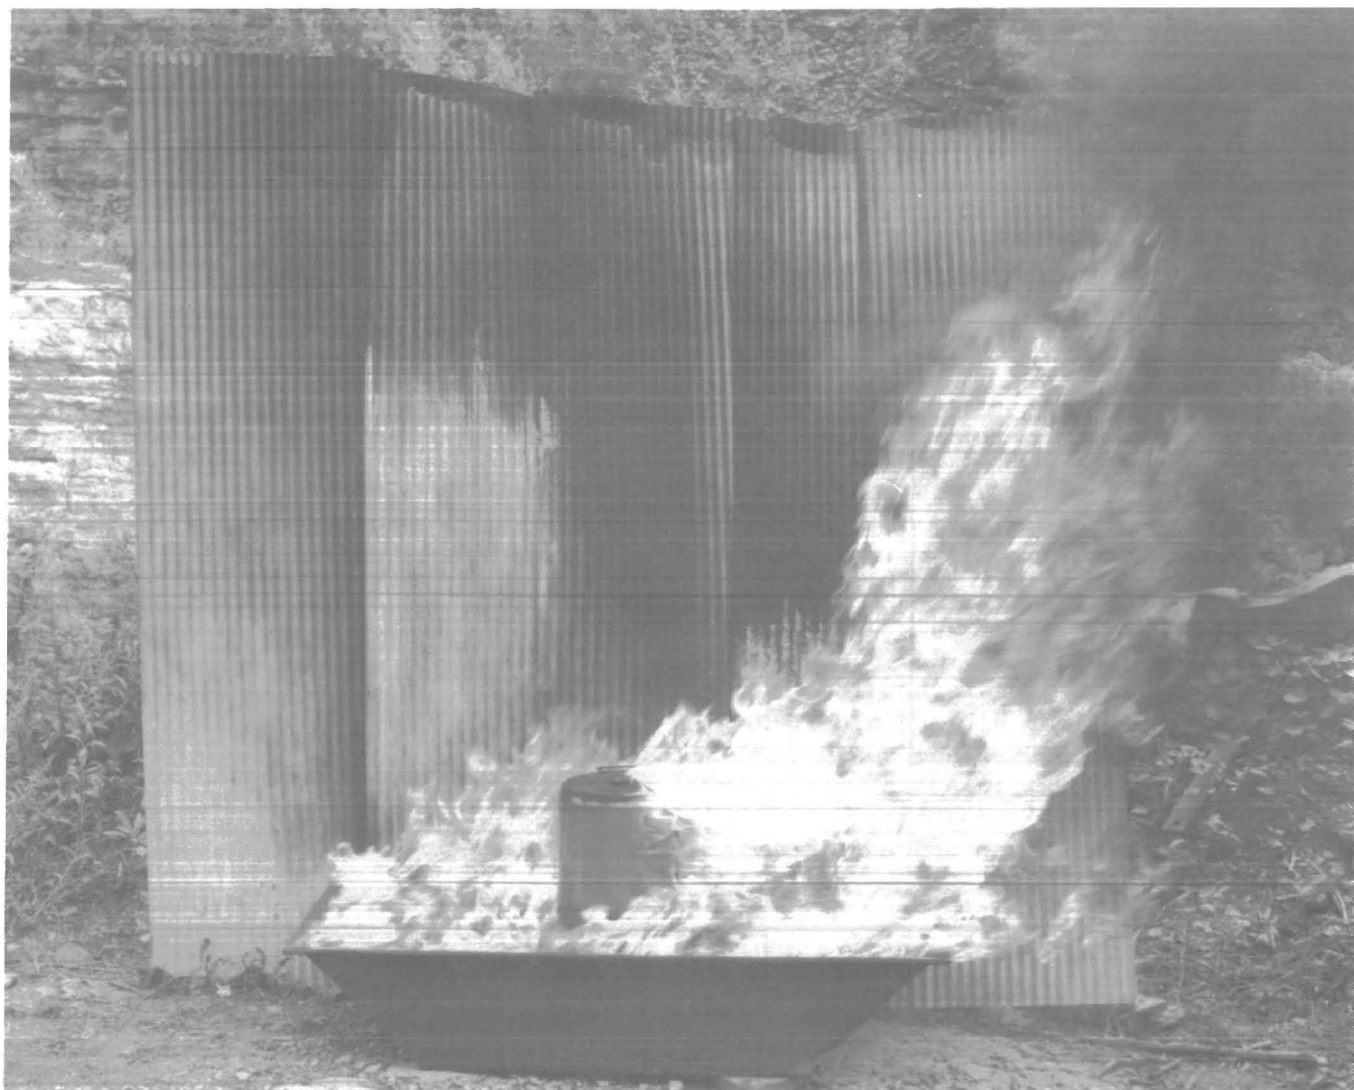
FIGURE 9. - Usual mode of pressure release from black container (flame jet near screw cap closure).

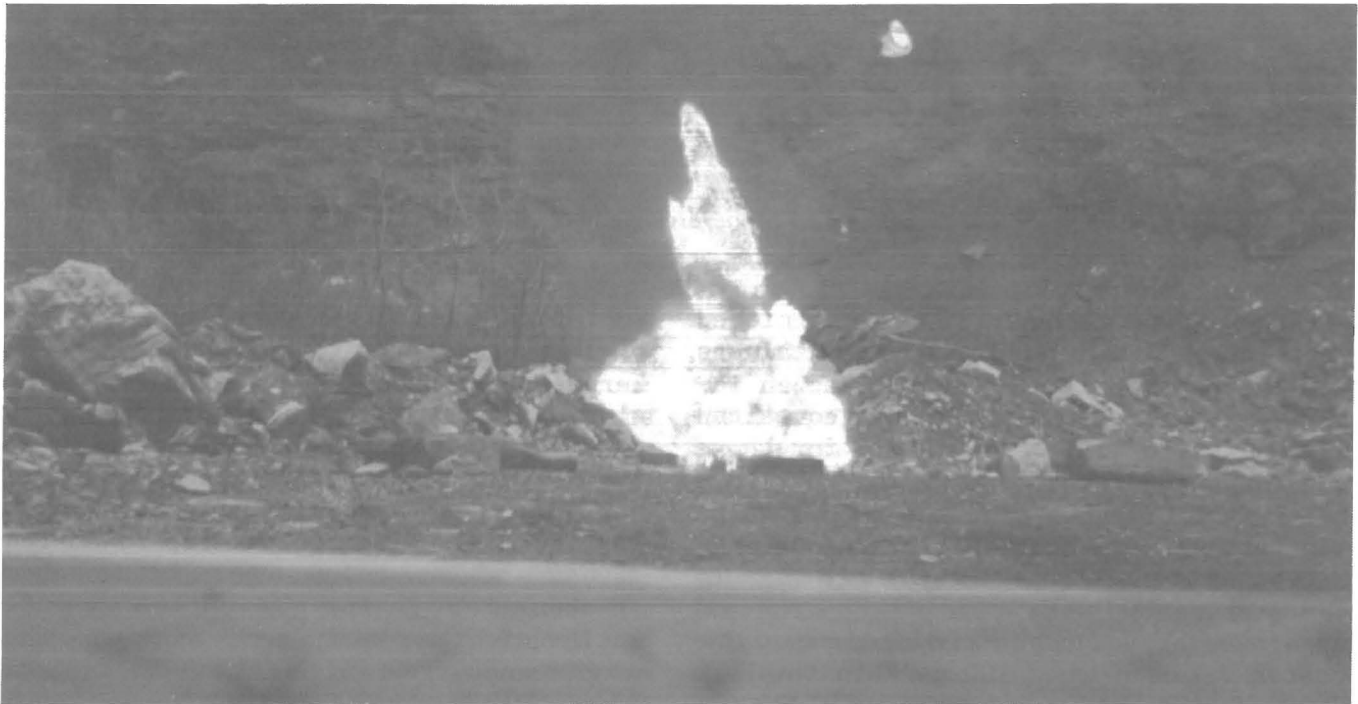
FIGURE 10. - Fire ball and black container jetting about 20 ft into the air due to explosion of kerosene vapor and air after 35-s exposure to tray fire.

Five of the metal containers that passed the standard tray fire test were also tested using 1 gal of kerosene in the container instead of NFR hydraulic oil. The time to rupture was about the same as before, but the violence of the rupture was striking. Figure 10 shows a black container jetting 20 ft into the air and an accompanying fire ball about 35 s after tray fire ignition.

Use of kerosene in this container is not recommended since 3 out of 10 containers were violently ejected when kerosene container contents were used (figs. 10 and A-2). The seven other containers opened at the upper seams and/or gaskets after about 1 min.

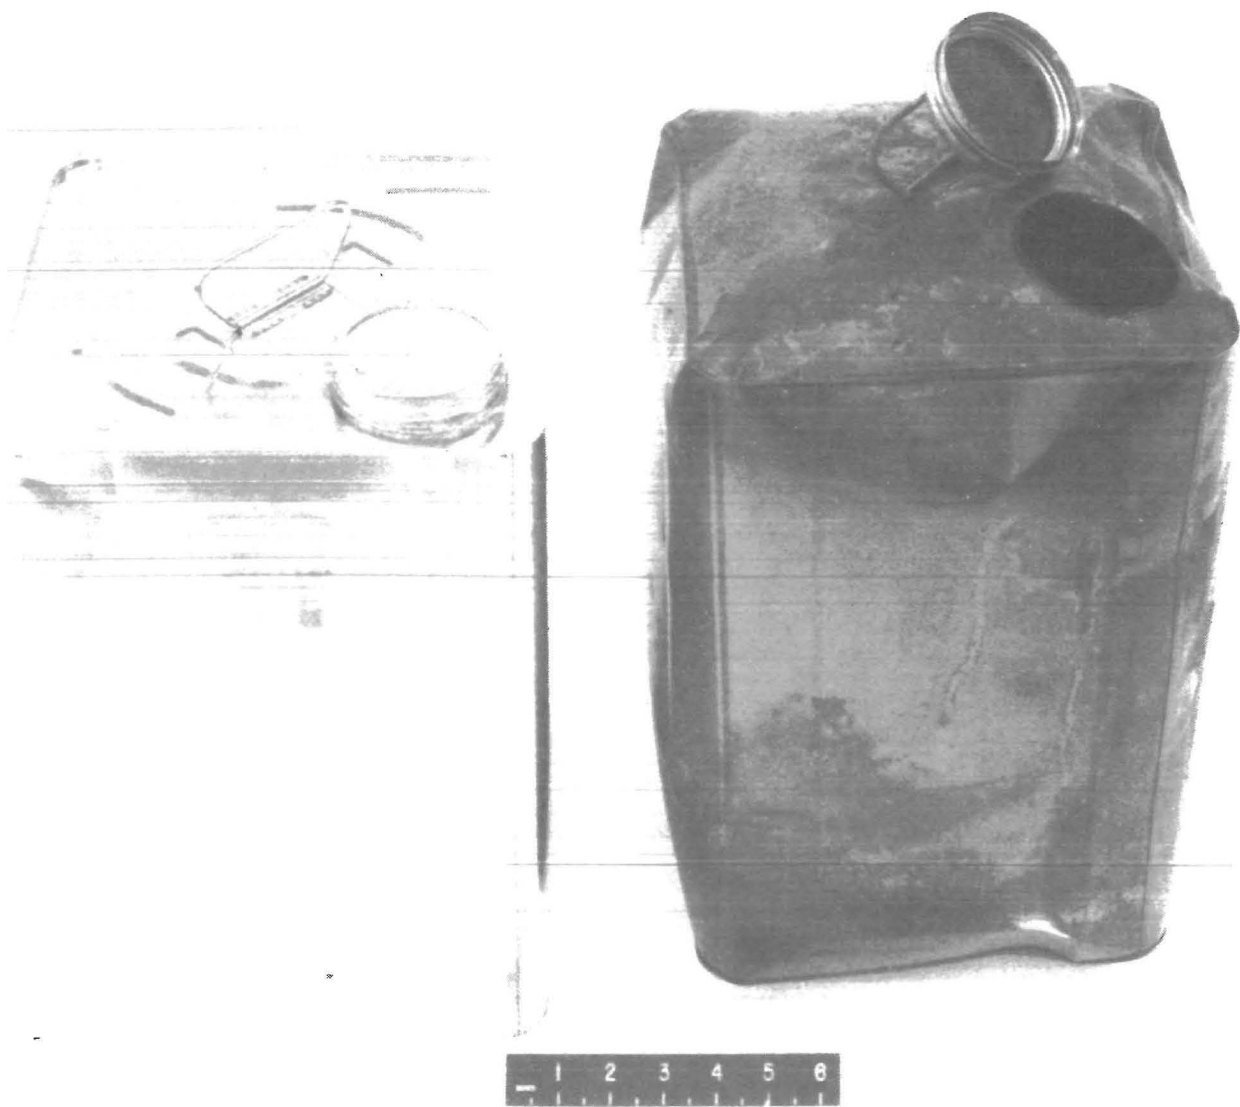
FIGURE A-7. - Square cans before and after standard tray fire (NFR oil contents) showing usual opening at top screw-cap seam (right).

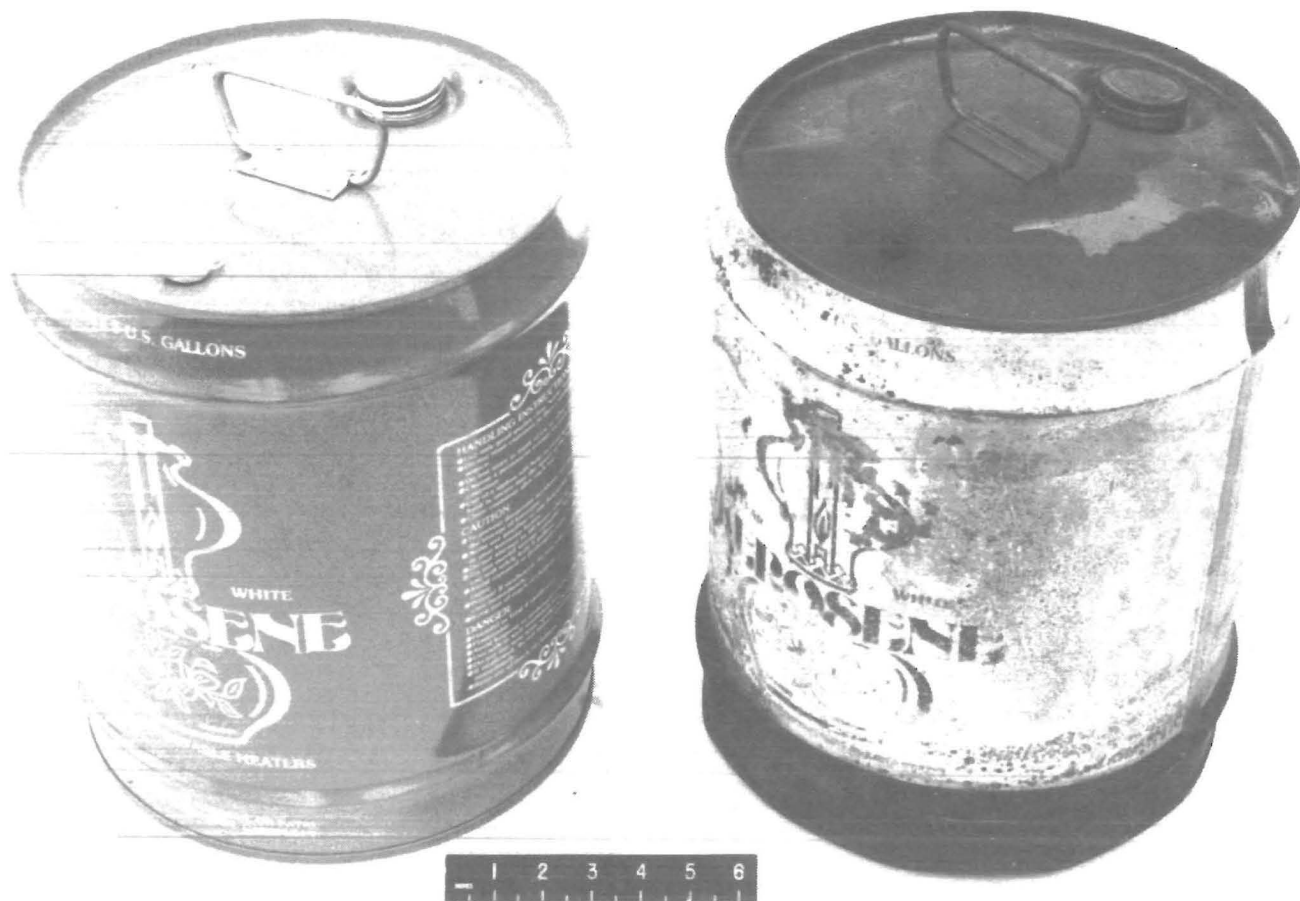
FIGURE A-8. - Vented dark blue metal containers before and after standard tray fire (NFR oil contents) with blown-off plastic vent missing (right).

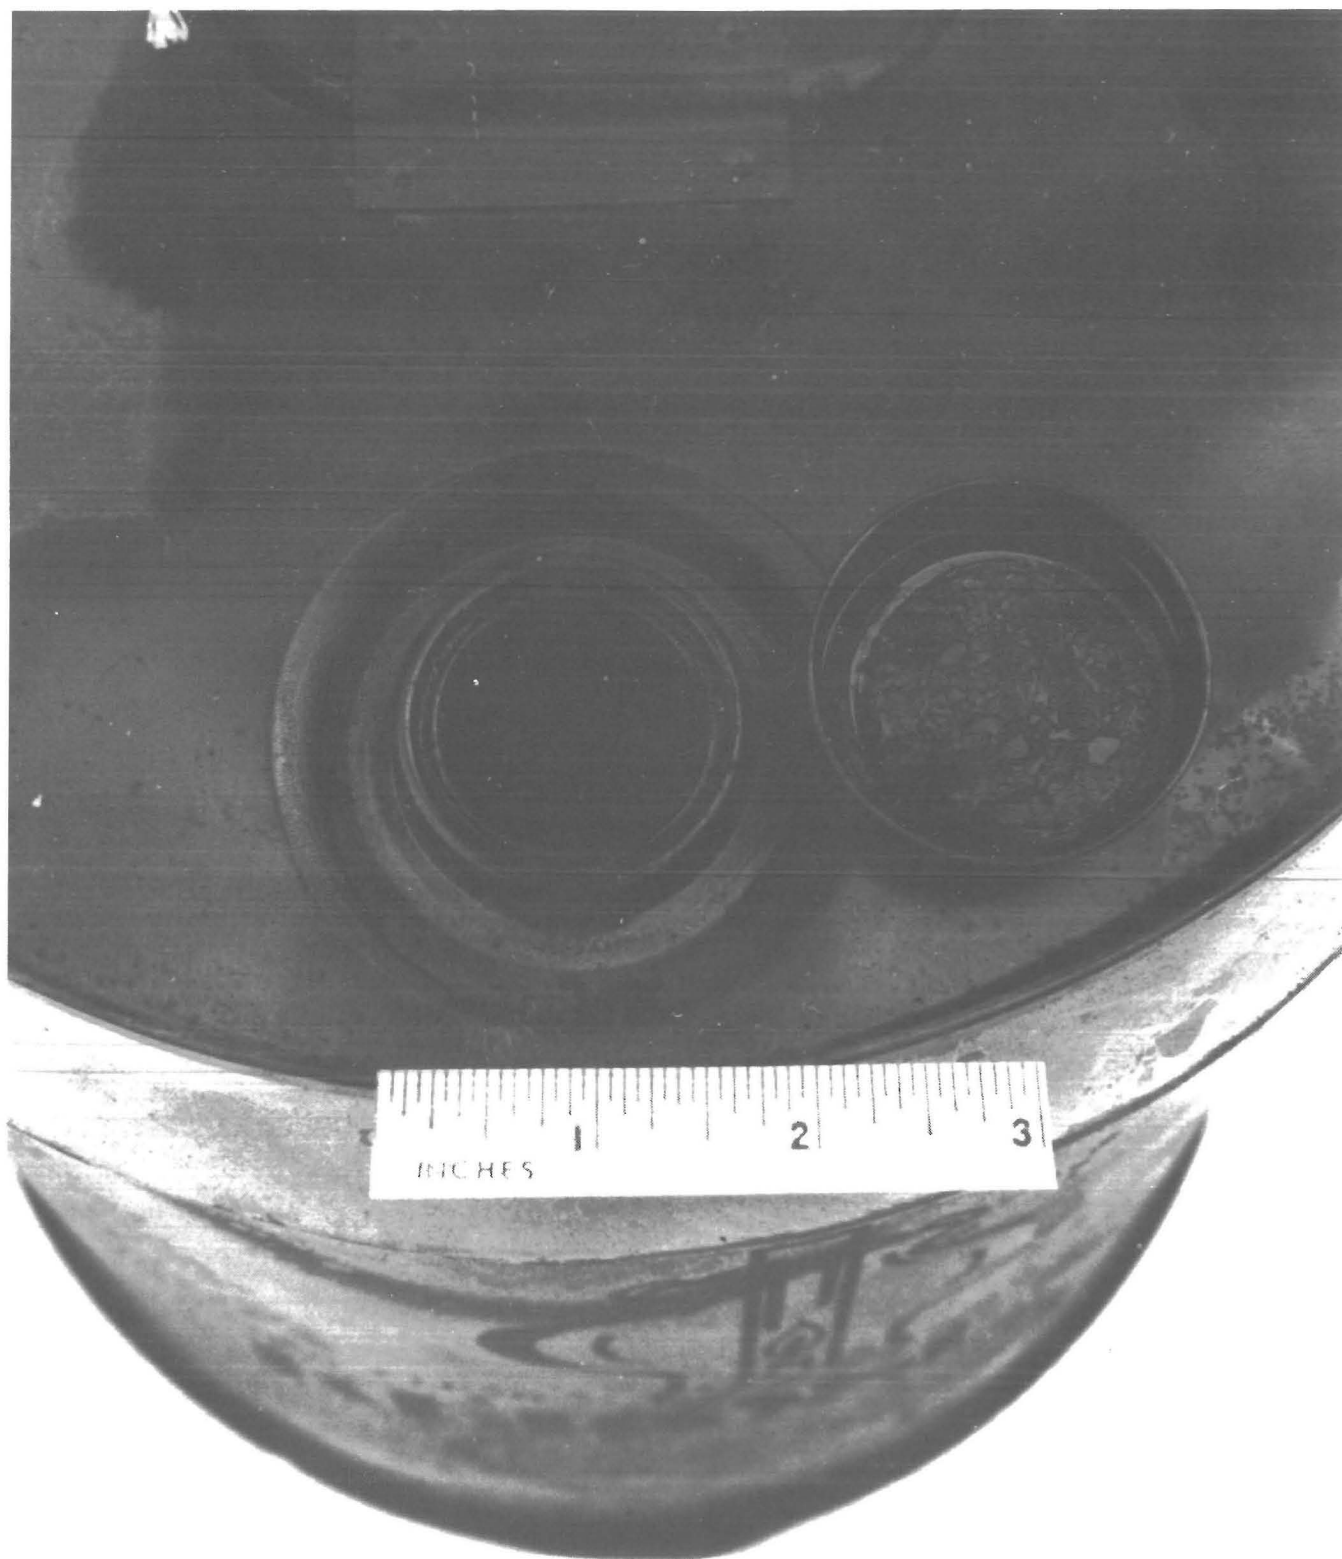
FIGURE A-9. - Vented dark blue container after standard tray fire (NFR oil contents) showing usual charring of screw-cap gasket.

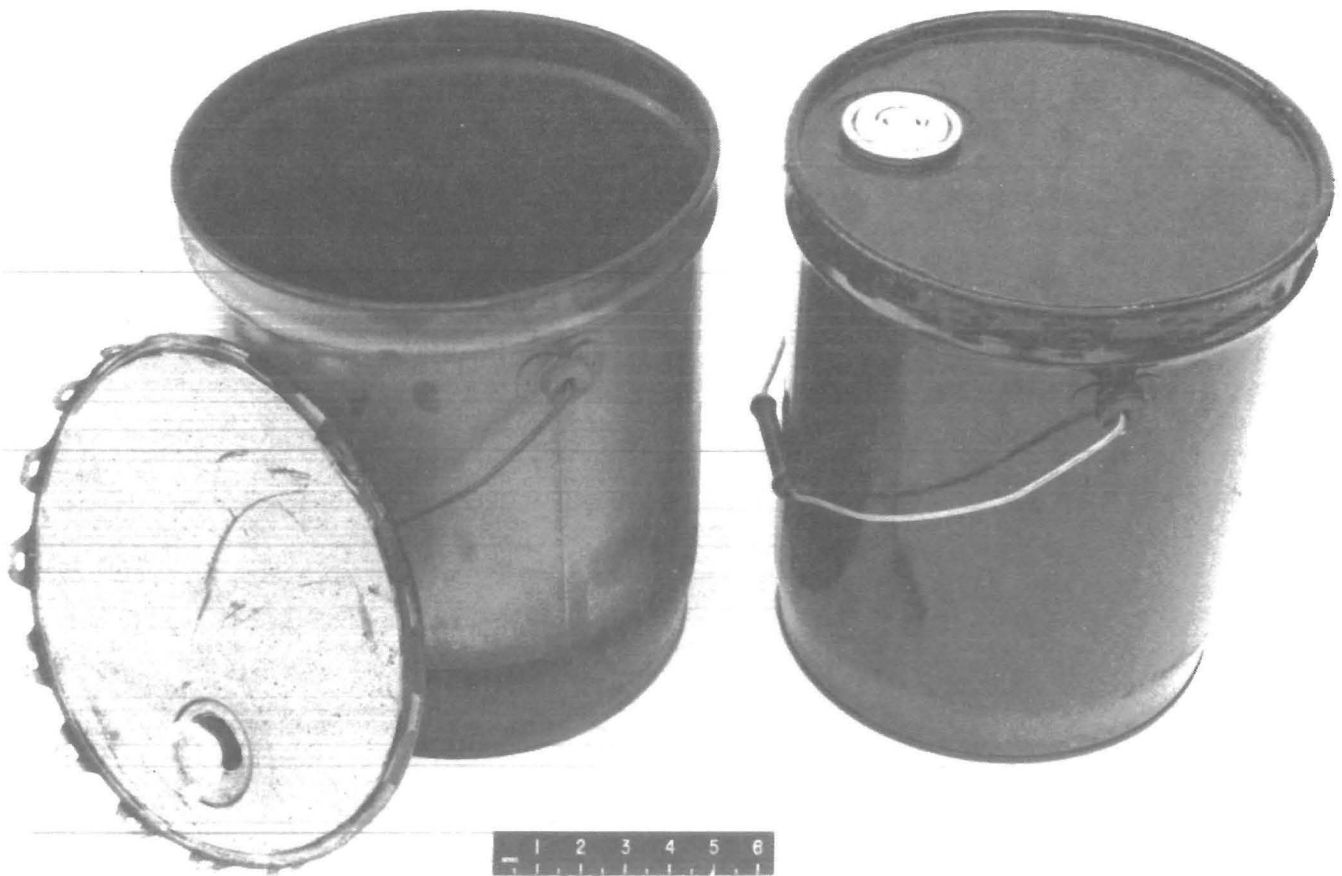
FIGURE A-12. - Open-head metal pails before and after standard tray fire (NFR oil contents). Plastic folding spout melted, but pressure was relieved when the lid blew off (left)

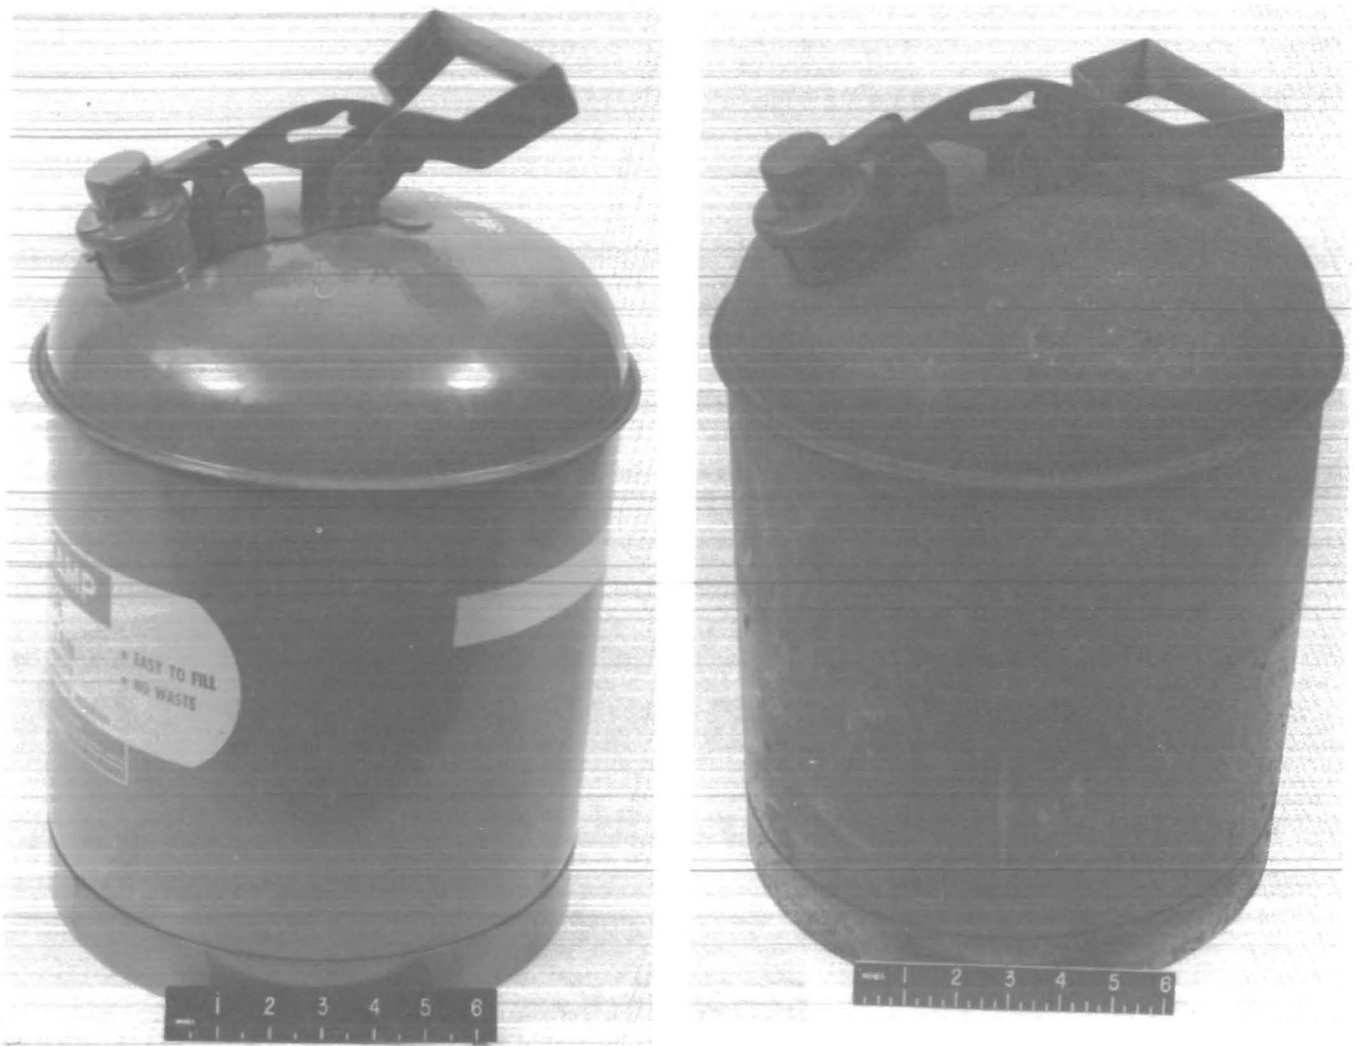
FIGURE A-15. - Metal safety containers before and after standard tray fire (NFR oil contents).
